REAL ESTATE WEEKLY

Restored landmark cupola graces skyline at 48 Wall

Kent M. Swig, president of Swig Equities, LLC, announced the recent completion of the repair and restoration work of the magnificent coppered eagle cupola that sits atop of the 36th floor of 48 Wall Street.

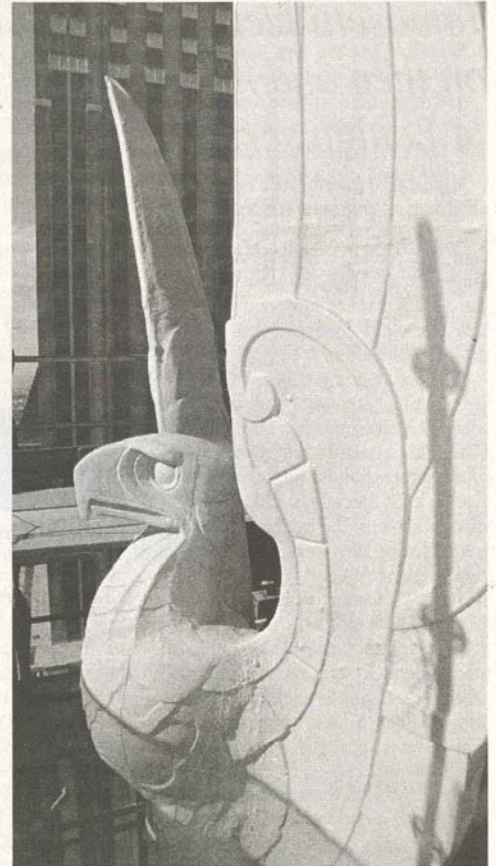
48 Wall's restored and repaired landmark cupola.

Prior to the restoration, a conditions assessment was carried out. The investigation revealed the development of cracks in the seams of the copper sheathing, which had allowed water to infiltrate and deteriorate the internal supporting steel structure and the cement fire-proof encasing that surround the steel structure.

In an effort to address the structural and material failure issues and to preserve the historic fabric of the copper eagle, the copper sheathing was removed so the holes and broken seams could be patched and replaced, and the steel structure was replaced entirely.
